Field Test for Air Sealing on Chimney Balloon Damper*

Test Date: August 19, 2008

Conducted by: Mark Furst, Energy Rater and owner of Grading Spaces LLC

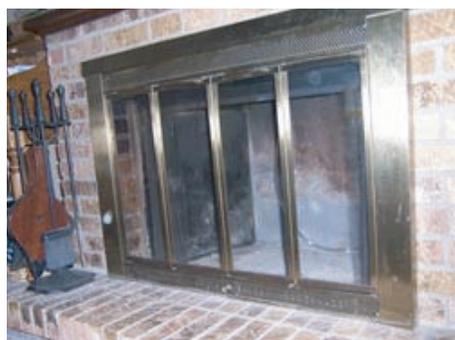
Fireplace Data: Majestic L36B Zero Clearance fireplace with 9" metal flue, Sears bifold tempered glass doors, A flapper style downward opening metal damper

Fireplace Condition	Results in cfm
Damper open / No Damper	1720
Glass Doors closed only	1323
Damper closed only	1470
Damper closed & Glass doors closed	1280
Chimney Balloon installed only	1250

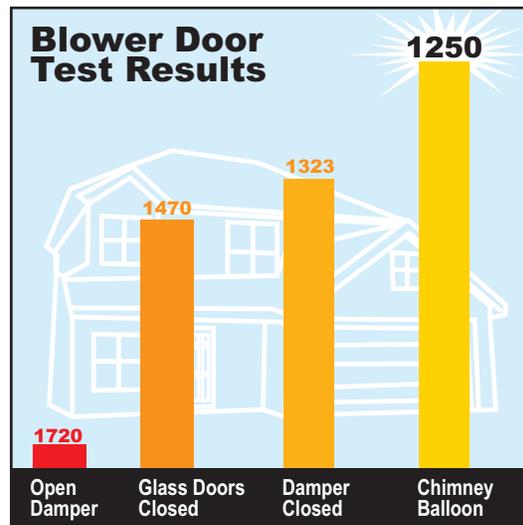
Testing Results: The house was depressurized to -50 pascals (with respect to the outside) at each condition using a Minneapolis Blower Door and the flow reading noted.

Testing Notes: These results show that the Chimney Balloon achieved an overall improvement of 27% from the worst case "all open" condition. The damper and doors on this fireplace were in good condition and worked relatively well, however, many chimneys and their components I inspect are not in as good condition as these, so the contribution of the damper and/or doors to air sealing will often be much less.
